SUBJECT: Animal Feeding Operation (AFO) Compliance Inspection for:

- Ken Bidwell – Section 19, County – Benton, Facility #56957

NOTICE OF VIOLATION

IOWA DEPARTMENT OF NATURAL RESOURCES AFO INSPECTION REPORT

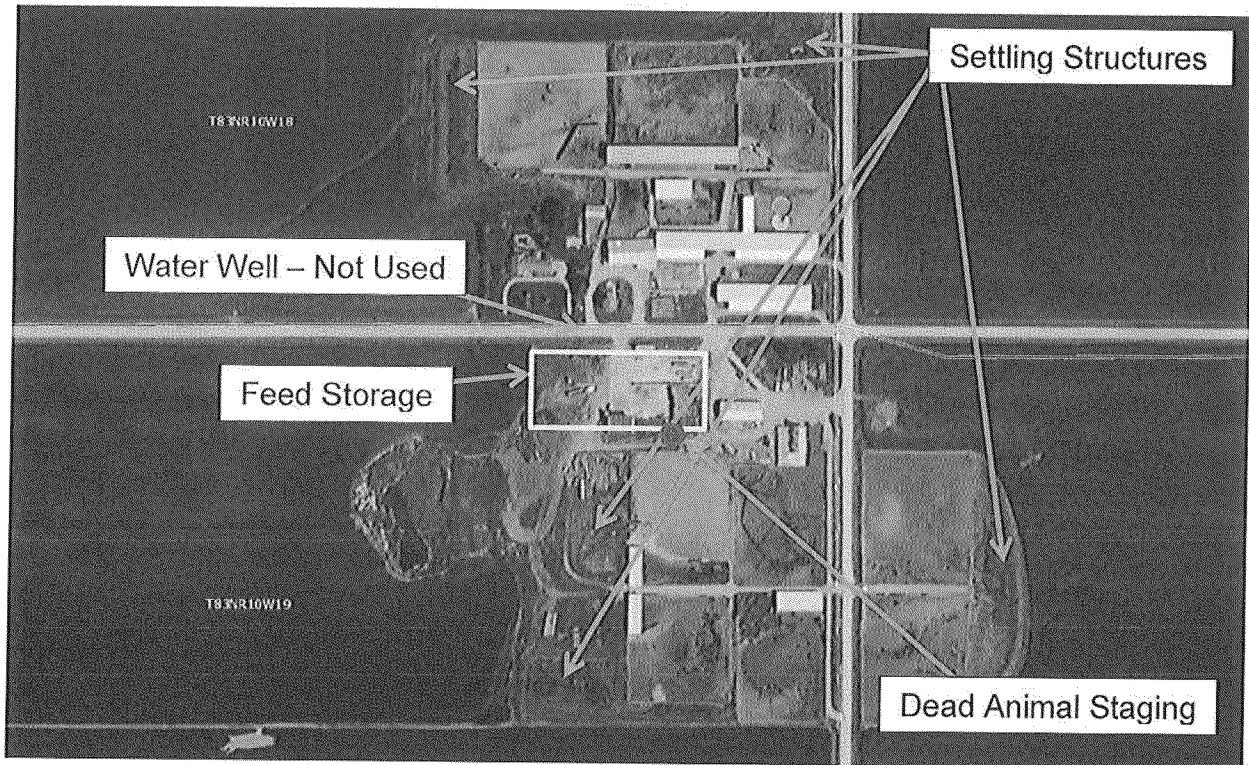
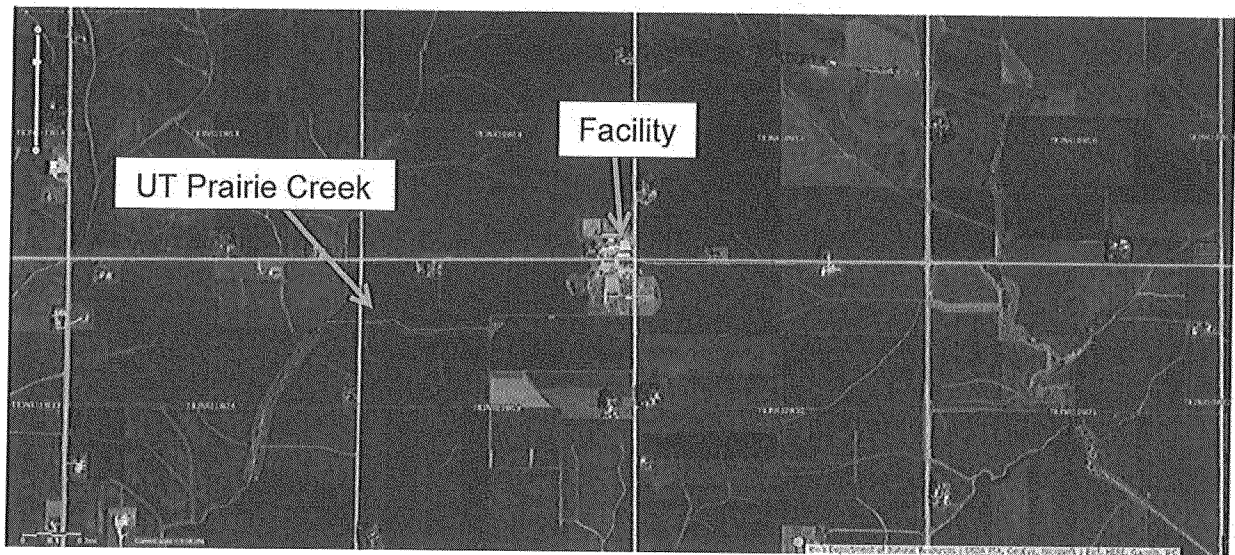
Ken Bidwell – Section 19
2285 71st Street
Van Horne, Iowa 52346
Facility ID# 56957

This facility consists of (8) open feedlot buildings with several pens housing a capacity of 2,200 beef cattle. Below the open feedlots are (5) settling structures. Mortalities are disposed of by rendering. Mr. Ken Bidwell, owner, was present and interviewed during the inspection.

Downslope of the feedlots is (5) grassed settling areas. It appeared that all waste from the feedlots, the feed storage area, and the mortality staging area flows into one of the settling areas. The settling areas consist of a flat grassed area with berms built around. The settled effluent flows through the structure and then through a series of sinuous grassed waterways. No evidence of discharge was observed and no evidence of past discharges was observed.
